DEPARTMENT OF TRANSPORTATION

Quality Assurance and Source Inspection

Contract #: 04-0120F4Cty: SF/ALA Rte: 80 PM: 13.2/13.9File #: 99.28**WELDING INSPECTION REPORT****Resident Engineer:** Casey, William**Address:** 333 Burma Road**City:** Oakland, CA 94607**Report No:** WIR-029249**Date Inspected:** 13-Mar-2013**Project Name:** SAS Superstructure**OSM Arrival Time:** 630**Prime Contractor:** American Bridge/Fluor Enterprises, a JV**OSM Departure Time:** 1430**Contractor:** American Bridge Manufacturer**Location:** Reedsport, Oregon**CWI Name:** David Speakman**CWI Present:** Yes No**Inspected CWI report:** Yes No N/A**Rod Oven in Use:** Yes No N/A**Electrode to specification:** Yes No N/A**Weld Procedures Followed:** Yes No N/A**Qualified Welders:** Yes No N/A**Verified Joint Fit-up:** Yes No N/A**Approved Drawings:** Yes No N/A**Approved WPS:** Yes No N/A**Delayed / Cancelled:** Yes No N/A**Bridge No:** 34-0006**Component:** Fog Horn Support/Cable hand rail posts**Summary of Items Observed:**

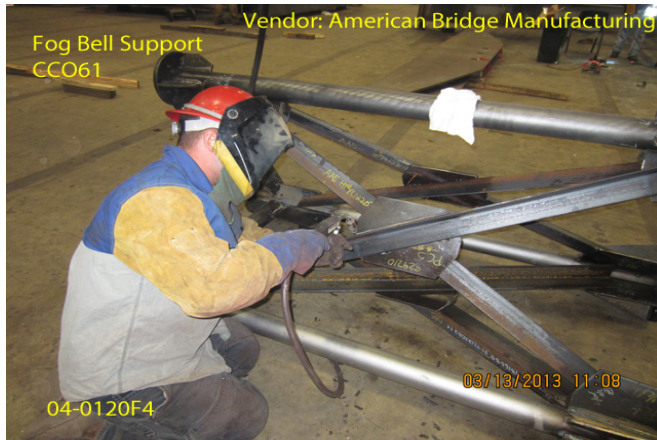
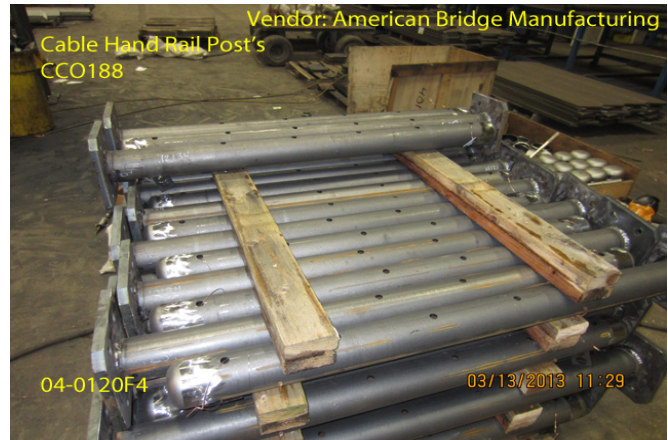
This QAI observed ABM personnel performing fit up, tack welding operations, and in progress production welding of multiple parts for the Fog Horn and Fog Bell supports. The ABF approved drawing numbers utilized were sheet numbers 5A and 6. The Fog Horn Support, piece mark # 6C1 and the Fog Bell Support, piece mark # 5F1. The ABM Welder was Joe Lacort (ID# EA) and utilizing ABM FCAW WPS #ABM-SAS-07, Rev. 1.

This QAI observed ABM personnel performing fit up and tack welding operations of multiple parts for the hand rail post's, piece mark VF. The ABF approved drawing sheet # 403D. The ABM Welder was Mike Herbert (ID# H) and utilizing FCAW WPS #ABM-SAS-031 and WPS #ABM-SAS-035.

The QAI observed ABM Quality Control Inspector (QCI) Mike Inman monitor the fit up and welding operations, checking pre-heat and interpass temperatures, perform dimensional and visual inspection. The QAI observed that items witnessed appeared to be in conformance with the approved drawings noted above, the standard specification and special provisions. This Inspection report was performed by James Doe Lot# B358.
